UNITED STATES DISTRICT COURT WESTERN DISTRICT OF TEXAS AUSTIN DIVISION

JON R. DEUTSCH	§	
	§	CIVIL ACTION NO. 1:16-CV-73
Plaintiff	§	
	§	
VS.	§	
	§	
JESUE LLC and JASAN LLC	§	
	§	
Defendant	§

COMPLAINT

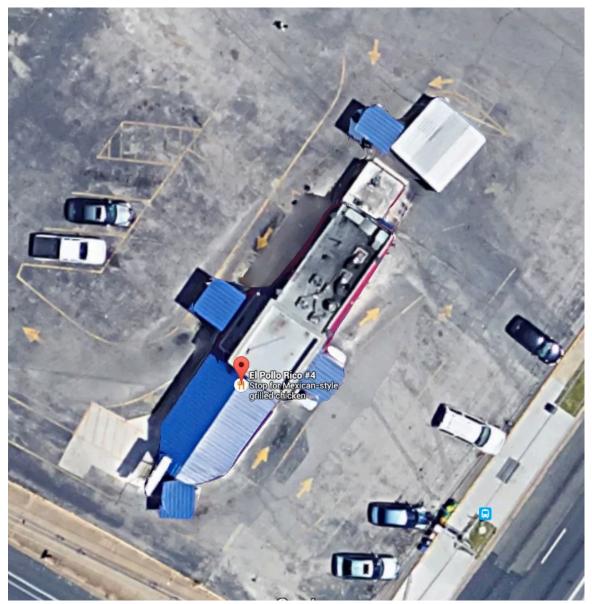
Fig. 1 - Overhead view of EL POLLO RICO #4 AUSTIN IN 2015.

Satellite Images from *Texas General Land Office, Texas Orthoimagery Program, U.S. Geological Survey, 2015.* Note: This property has zero ADA-Compliant Van Accessible Parking Spaces. Under the Americans with Disabilities Act, this business must have 1 ADA-Compliant Van Accessible Parking Space (96" Wide with 96" Side Access Aisle).
